MILAM ELEMENTARY SCHOOL ROOF REPLACEMENT

The subject facility is a functioning elementary school that was originally constructed in 1960's. The facility consists of four classroom wings and interconnected hallways and a cafetorium/kitchen structure. The existing roof on the classroom wings consisted of asphaltic shingles over plywood sheathing supported by open-web steel bar joists with a 6/12 slope. The roofs over the connecting hallways and the cafetorium/kitchen were low-sloped (1/4-inch per foot) assemblies consisting of gravel surfaced built-up roof membranes over rigid board insulation and fluted steel deck. As part of the renovation program instituted at the school and the budgetary development phase, a standing seam metal panel roof system was selected to be installed on the steep-sloped roof areas to provide not only a long-term serviceable roof system but also an aesthetically enhancing system. A torch-applied modified bitumen roof membrane over insulation board was selected for the low-slope roof areas.

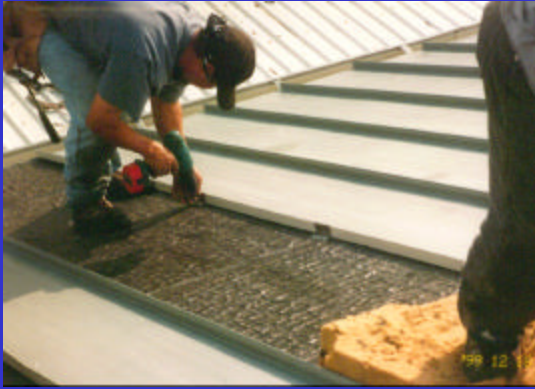
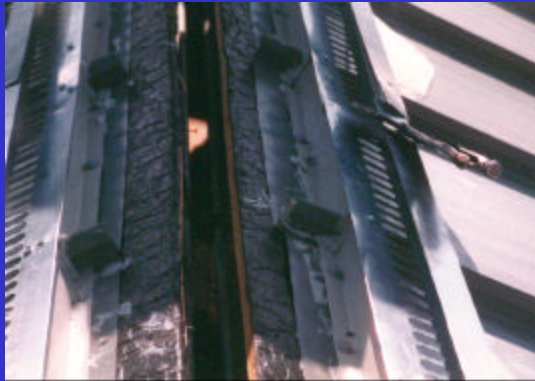
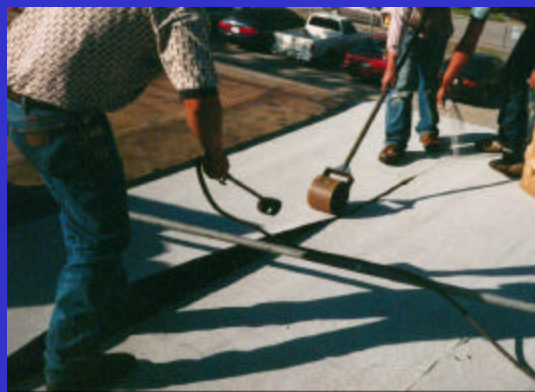
The existing plywood sheathing was found to be severely deteriorated and believed to be the result of the lack of proper ventilation in the attic space located between the deck and the interior ceilings. As part of the roof replacement project, new plywood sheathing was installed and continuous ridge and soffit vents were installed. A self-adhering elastomeric underlayment was installed over the sheathing, clips fastened to the sheathing and continuous length, eave-to-ridge, pre-finished, Kynar 500 standing seam metal panels were secured to the clips. The BUR roof membrane was removed down to the steel deck, polyisocyanurate rigid board insulation loose-laid over the deck, and a fiberglass base sheet was mechanically attached on top of the insulation board and into the deck and a two-ply, torch-applied modified bitumen roof membrane was fully-adhered to the base color were installed on the purlins. Pre-finished sheet metal flashings, color to match the metal roof panels, were utilized on the low-slope roof.

Special details utilized and installed consisted of a venting-type ridge cap, venting-type details along the eaves and rakes, pre-manufactured curbs (color to match), pre-fabricated boot flashings at penetrations, gutters/downspouts and transitional flashings at the intersections of the steep slope to the low-slope roof areas. A manufacturer's twenty-year watertightness warranty was issued for the SSMR system and a full-system no-dollar-limit 20-year warranty was issued on the modified bitumen roof.
